Re: Dangerous Waste Compliance Inspection at United States Department of Energy Hanford
Facility, Central Waste Complex (CWC) on March 7, 8, 14, 15, 2012.
RCRA Site ID: WA7890008967

**Washington Department of Ecology
Hazardous Waste & Toxics Reduction Program
Compliance Report**

Site : Hanford CWC Facility RCRA ID#: WA 7 89000 8967
Inspection Date: March 7, 8, 14, 15, 2012
Site Contacts: Mike Collins, US Department of Energy (USDOE)
Stu Mortensen, CH Plateau Remediation Company (CHPRC)
Joel Williams, CHPRC
Paul T. Karschnia, Materials and Energy Corporation (M&EC)

Amendment to March, 2012 CWC Inspection Report
Kerry A. Graber, Hazardous Waste Inspector KAG
July 3, 2013

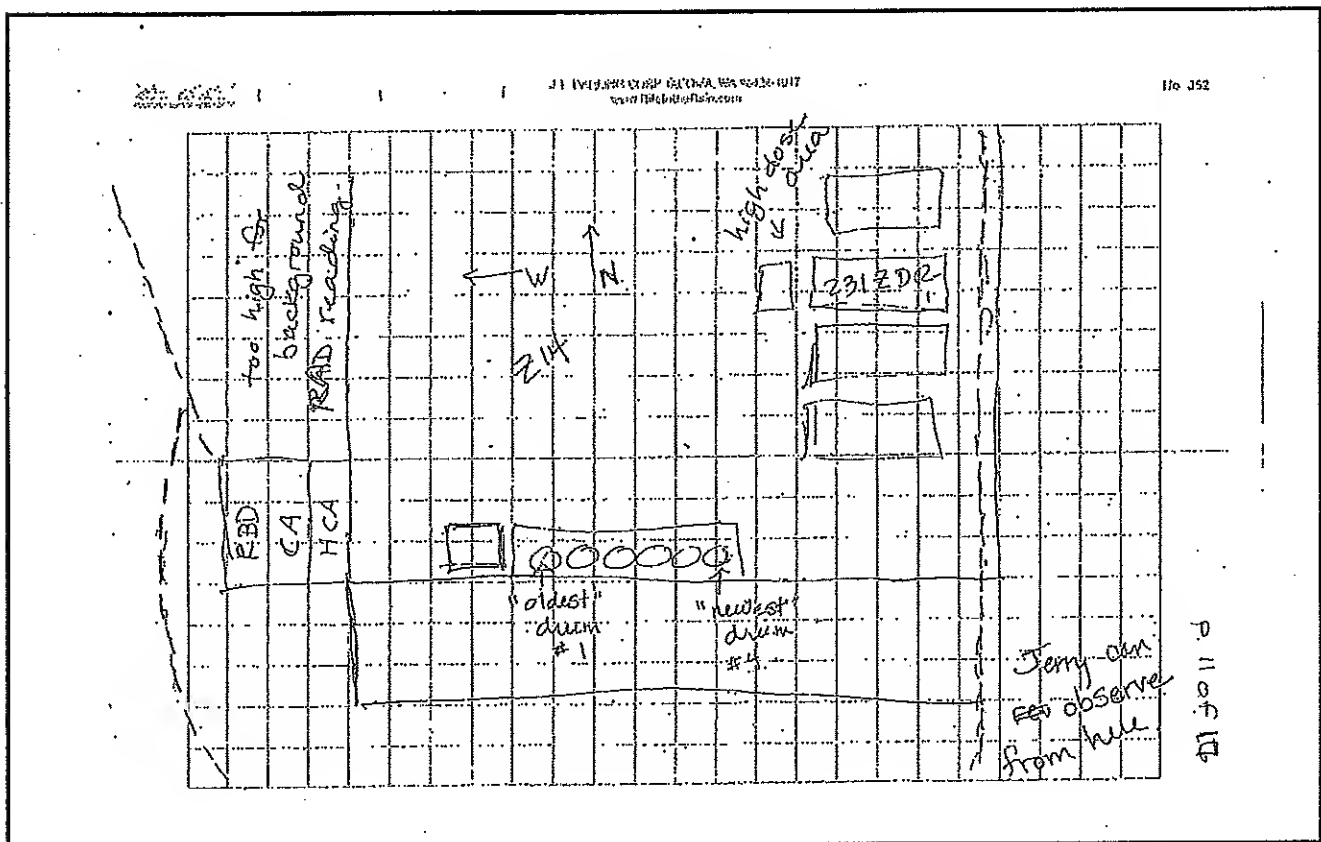
The briefing adjourned at 10:10, and Joannette and I continued our paperwork review and interviews in the CWC office. Jerry Yokel brought our own sample bottles, and accompanied the sample crew out to the box to observe the sampling. (The sample crew used their sample collection containers that contained a preservative, whereas the unused Ecology containers for "metals" samples did not.)
